RTDF2009-18024

ROOT CAUSE OF UNDESIRE HOSE SEPARATIONS AND A SOLUTION

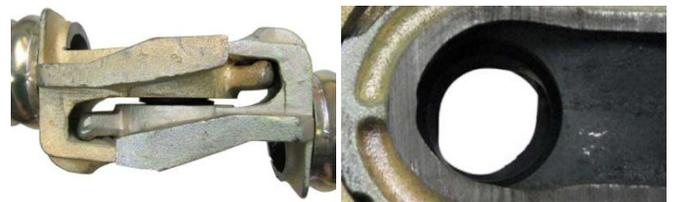
It was observed at several railroad facilities [1], as well as demonstrated in the test lab, that a gladhand gasket can both roll and twist when two gladhands are coupled while still maintaining pressure (Fig. 3, 4)

FIGURES 3 & 4: MISALIGNED GLADHAND GASKETS

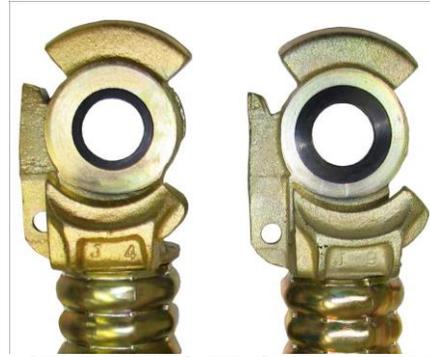
Gladhand gaskets can become misaligned easily with current dimensions. This is primarily due to the geometry of the gasket [5]. The current gasket can easily be moved and shifted inside the gasket groove. The proposed solution is to double the width of the gasket sidewall thickness (Fig.6) thus increasing its resistance to deformation when coupling two gladhands. This will also prevent it from being misaligned due to the larger surface area.

FIGURE 6: STANDARD GASKET VS. DOUBLE WIDE GASKET

The double wide gasket has a mating sidewall thickness of 0.312”, compared with the current sidewall thickness of 0.156”. The bigger sidewall gives the gasket added strength which prevents it from rolling and twisting in the gasket groove. It incorporates much more material than the current design, thus making it harder to roll and deform in the gasket groove.

The double wide gasket has a surface area of 1.470 in², compared to the 0.659 in² surface area of the current design. The increase in surface area prevents the gaskets from being misaligned, since the contact area is significantly greater than the amount the gasket can deform in the gasket groove. The greater surface area, coupled with a slightly lower durometer rubber, also results in greater adhesive friction between mating gaskets, helping them stay together. The inner diameter of the double wide gasket has not been changed; it is still 1 3/16” as noted in AAR requirement M-602 [5] to allow for normal air flow in the brake system. All of these factors should ensure that the pull-apart force for an end hose equipped with the double wide gasket is always around the 600lb range and never drops substantially, even with an inexperienced person coupling them.
